Leak Report

Project Name: S532 ÖRNEK HAVA KAÇAK RAPORU
Customer: XXXXXXXXXXXX
Address: XXXXXXXXXXXX
İSTANBUL
TÜRKİYE
Start Date: 2024-11-06
End Date: 2024-11-08

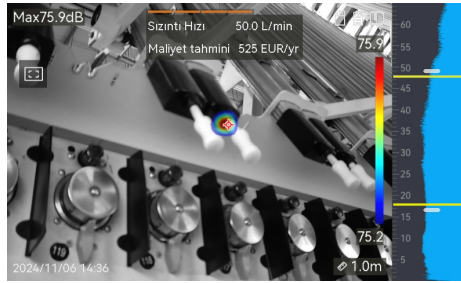
Tag	Leak Info	Losses
027	Location: MAKİNA 1 Group: SARIM Grade: 4 Distance: 1.0 m Recorded: 2024-11-06	50.0 l/min 525 EUR/year Sound Level: 75.9 dB Last updated: 2024-11-08
Notes:	KONTROL VEYA DEĞİŞİM ÖNERİLİR.

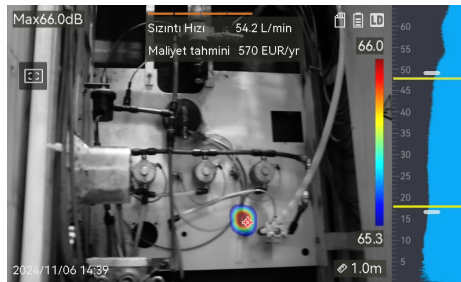
Tag	Leak Info	Losses
028	Location: PANO İÇİ Group: HORTUM GRUBU Grade: 4 Distance: 1.0 m Recorded: 2024-11-06	54.2 l/min 570 EUR/year Sound Level: 66.0 dB Last updated: 2024-11-08
Notes:	KONTROL VEYA DEĞİŞİM ÖNERİLİR.

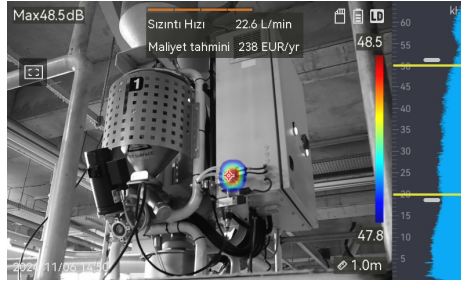
Tag	Leak Info	Losses
029	Location: PANO ÇIKIŞI Group: RAKOR Grade: 4 Distance: 1.0 m Recorded: 2024-11-06	22.6 l/min 238 EUR/year Sound Level: 48.5 dB Last updated: 2024-11-08
Notes:	KONTROL VEYA DEĞİŞİM ÖNERİLİR.

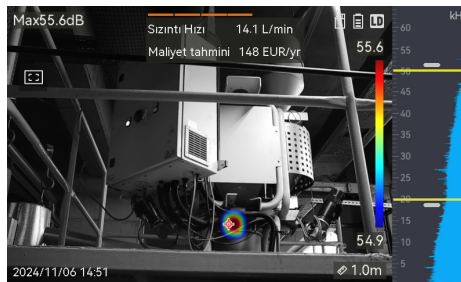
Tag	Leak Info	Losses
030	Location: PANO ÇIKIŞI Group: HORTUM GRUBU Grade: 4 Distance: 1.0 m Recorded: 2024-11-06	14.1 l/min 148 EUR/year Sound Level: 55.6 dB Last updated: 2024-11-08
Notes:	KONTROL VEYA DEĞİŞİM ÖNERİLİR.

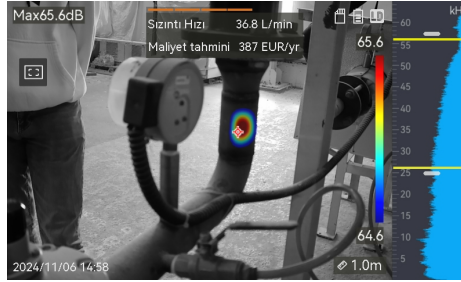
Tag	Leak Info	Losses
031	Location: MAKİNA 5 Group: BASIÇLI HAVA GİRİŞİ Grade: 4 Distance: 1.0 m Recorded: 2024-11-06	36.8 l/min 387 EUR/year Sound Level: 65.6 dB Last updated: 2024-11-08
Notes:	KONTROL VEYA DEĞİŞİM ÖNERİLİR.

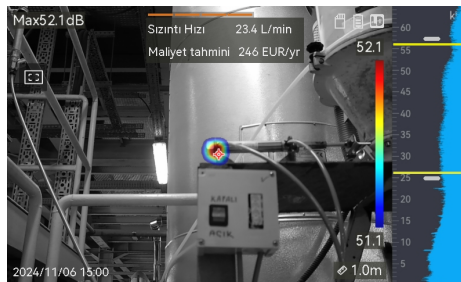
Tag	Leak Info	Losses
032	Location: MAKİNA 8 PANO ÜSTÜ Group: RAKOR Grade: 4 Distance: 1.0 m Recorded: 2024-11-06	23.4 l/min 246 EUR/year Sound Level: 52.1 dB Last updated: 2024-11-08
Notes:	KONTROL VEYA DEĞİŞİM ÖNERİLİR.

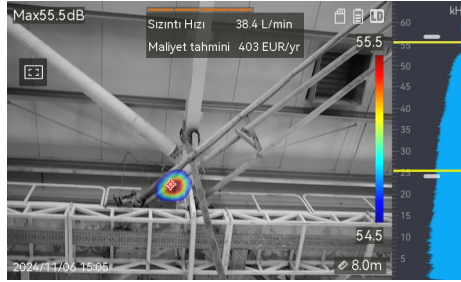
Tag	Leak Info	Losses
033	Location: MAKİNA 5 ÜSTÜ Group: BASINÇLI HAVA HATTI Grade: 4 Distance: 8.0 m Recorded: 2024-11-06	38.4 l/min 403 EUR/year Sound Level: 55.5 dB Last updated: 2024-11-08
Notes:	KONTROL VEYA DEĞİŞİM ÖNERİLİR.

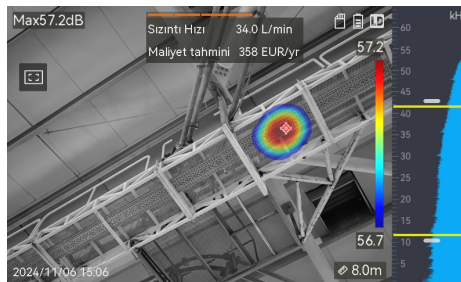
Tag	Leak Info	Losses
034	Location: MAKİNA 3 ÜSTÜ Group: BASINÇLI HAVA HATTI Grade: 4 Distance: 8.0 m Recorded: 2024-11-06	34.0 l/min 358 EUR/year Sound Level: 57.2 dB Last updated: 2024-11-08
Notes:	KONTROL VEYA DEĞİŞİM ÖNERİLİR.

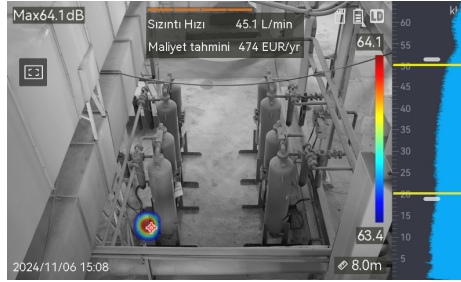
Tag	Leak Info	Losses
035	Location: KURUTMA TÜPÜ Group: TÜP ÜSTÜ RAKOR Grade: 4 Distance: 8.0 m Recorded: 2024-11-06	45.1 l/min 474 EUR/year Sound Level: 64.1 dB Last updated: 2024-11-08
Notes:	KONTROL VEYA DEĞİŞİM ÖNERİLİR.

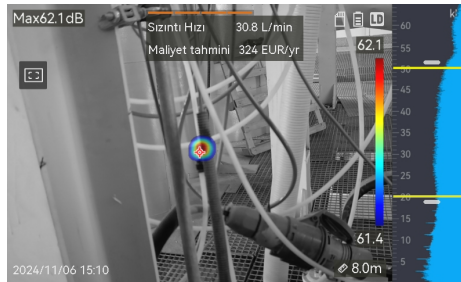
Tag	Leak Info	Losses
036	Location: MAKİNA 11 Group: HORTUM GRUBU Grade: 4 Distance: 8.0 m Recorded: 2024-11-06	30.8 l/min 324 EUR/year Sound Level: 62.1 dB Last updated: 2024-11-08
Notes:	KONTROL VEYA DEĞİŞİM ÖNERİLİR.

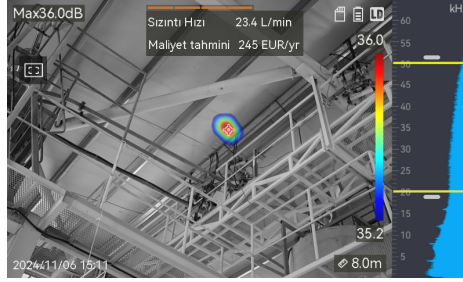
037

Location: MAKİNA 11 ÜSTÜ
Group: HAVA HATTI VANA GRUBU
Grade: 4 Sound Level:
Distance: 8.0 m
Recorded: 2024-11-06 Last updated: 2024-11-08

23.4 l/min
245 EUR/year
36.0 dB

Notes: KONTROL VEYA DEĞİŞİM ÖNERİLİR.
